MSCAA – Hurricane Creek Culvert Investigation

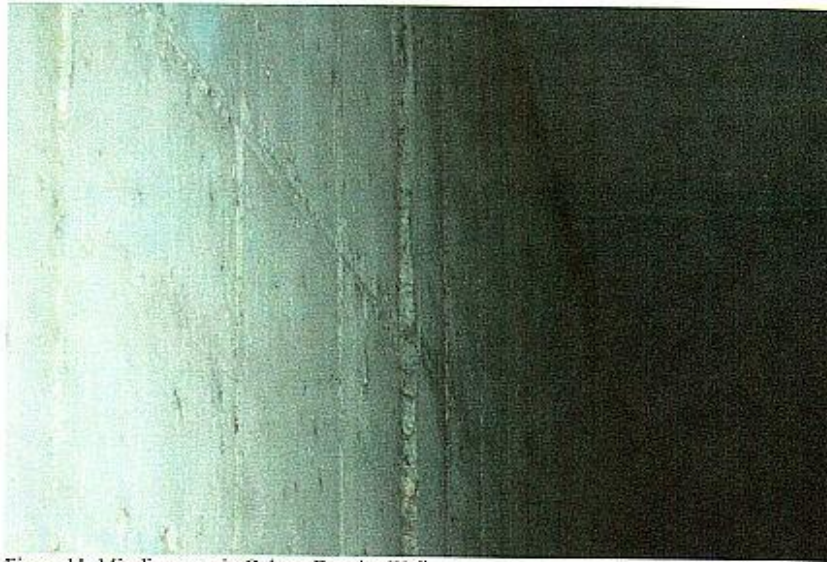
The interior and exterior side walls and base slab did not show any significant abrasion, cracking, bulging, or other deterioration of the exposed concrete surfaces. Appendix A, Figures 11 and 12 show an interior wall with misaligned concrete faces. This condition likely occurred during construction due a misalignment of concrete formwork that supports the plastic concrete while concrete was being poured. The formwork faces did not line up, therefore creating a difference in wall thickness. The side that protrudes is thicker than the design drawings dictate, and is therefore more robust than necessary. This condition does not affect the integrity of the structure and actually results in a thicker section with greater strength.

Figure 11: Misalignment in Culvert Exterior Wall

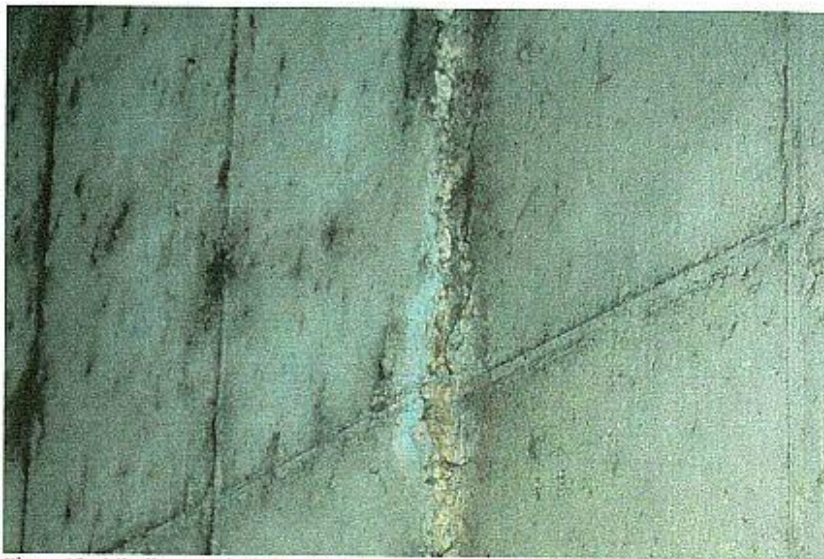
Figure 12: Misalignment in Culvert Exterior Wall
